Release Notes for the Catalyst 3750, 3560, and 2960 Switches, Cisco IOS Release 12.2(46)SE

Revised January 21, 2009

Cisco IOS Release 12.2(46)SE and later runs on all Catalyst 3750, 3560, and 2960 switches and on Cisco EtherSwitch service modules.

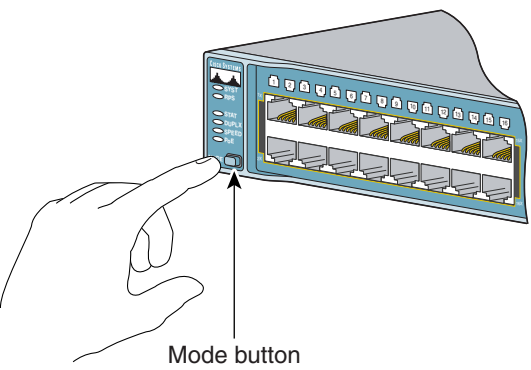
<p>Step 5 Press and hold the Mode button for 3 seconds. When all of the LEDs left of the Mode button turn green, release the Mode button.</p> <p>If the LEDs left of the Mode button begin to blink after you press the button, release it. Blinking LEDs mean that the switch has already been configured and cannot go into Express Setup mode. For more information, see the “Resetting the Switch” section.</p>

<p>Mode button</p>
<p>Step 6 Verify that the switch is in Express Setup mode by confirming that all LEDs left of the Mode button are green. (On some models, the RPS and PoE LEDs remain off.)</p>	
<p>Step 7 Connect a Category 5 Ethernet cable to any 10/100 or 10/100/1000 Ethernet port on the switch front panel.</p> <p>Connect the other end of the cable to the Ethernet port on your PC.</p>

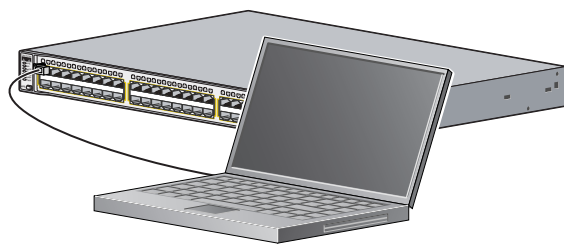
<p>DHCP-enabled PC</p>
<p>Step 8 Verify that the switch and PC Ethernet ports LEDs are green.</p> <p>Wait 30 seconds.</p>
